Report Number: 221467

GFL Environmental Inc.

34613 Vye Rd, Abbotsford, BC V2S 8J7

**Re: Warning Letter**

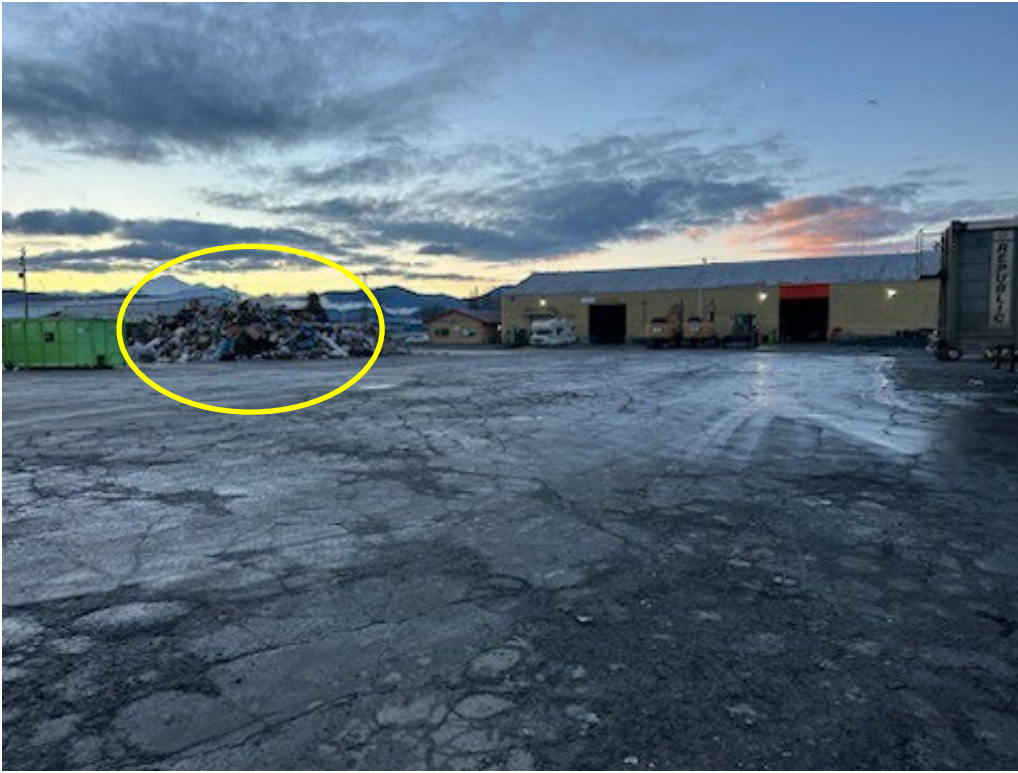
In the January 9, 2024, Information Request, the Environmental and Regulatory Manager informed Officer Angus that the uncovered waste materials consisted of construction and demolition waste. Officer Angus reviewed the photos of the Facility provided by the Environmental and Regulatory Manager and verified that the amount of waste material being stored outside and without cover has significantly reduced; however, the construction and demolition waste continue to be stored uncovered (Photos 1 and 2). In addition, Officer Angus observed significant asphalt cracking at the Facility, rendering the Facility's surface permeable (Photo 3).

Photo 1. View of the uncovered construction and demolition waste. Denoted by the yellow circle.

Cease the unauthorized discharge of waste to the environment.

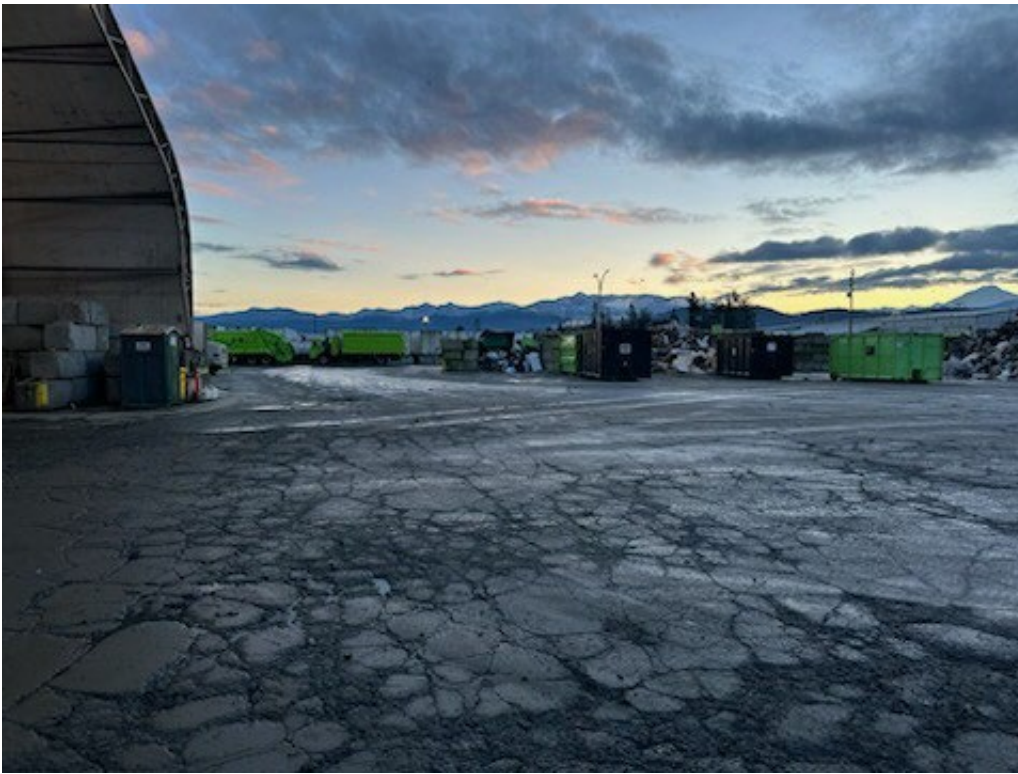
Municipal solid waste management is captured as a prescribed operation within Schedule 1 of the Waste Discharge Regulation Item 25 and is defined as "activities and operations for the management, treatment or discharge of refuse that (a) originates from residential, commercial, institutional, demolition, land clearing or construction sources, or (b) is included in a waste management plan." GFL generated effluent and introduced effluent into the environment from a prescribed operation. The effluent is discharged from the Facility to the environment from the southeast to a fish-bearing ditch network that enters Lonzo Creek and from the northeast, discharging to ground through a detention swale before going through an oil-water separator. In addition, the effluent is also discharged directly to the ground through significant cracks on the paved surface. Therefore, GFL is determined to be out of compliance with section 6(3) of EMA.

Photo 3. View of the significant asphalt cracking.

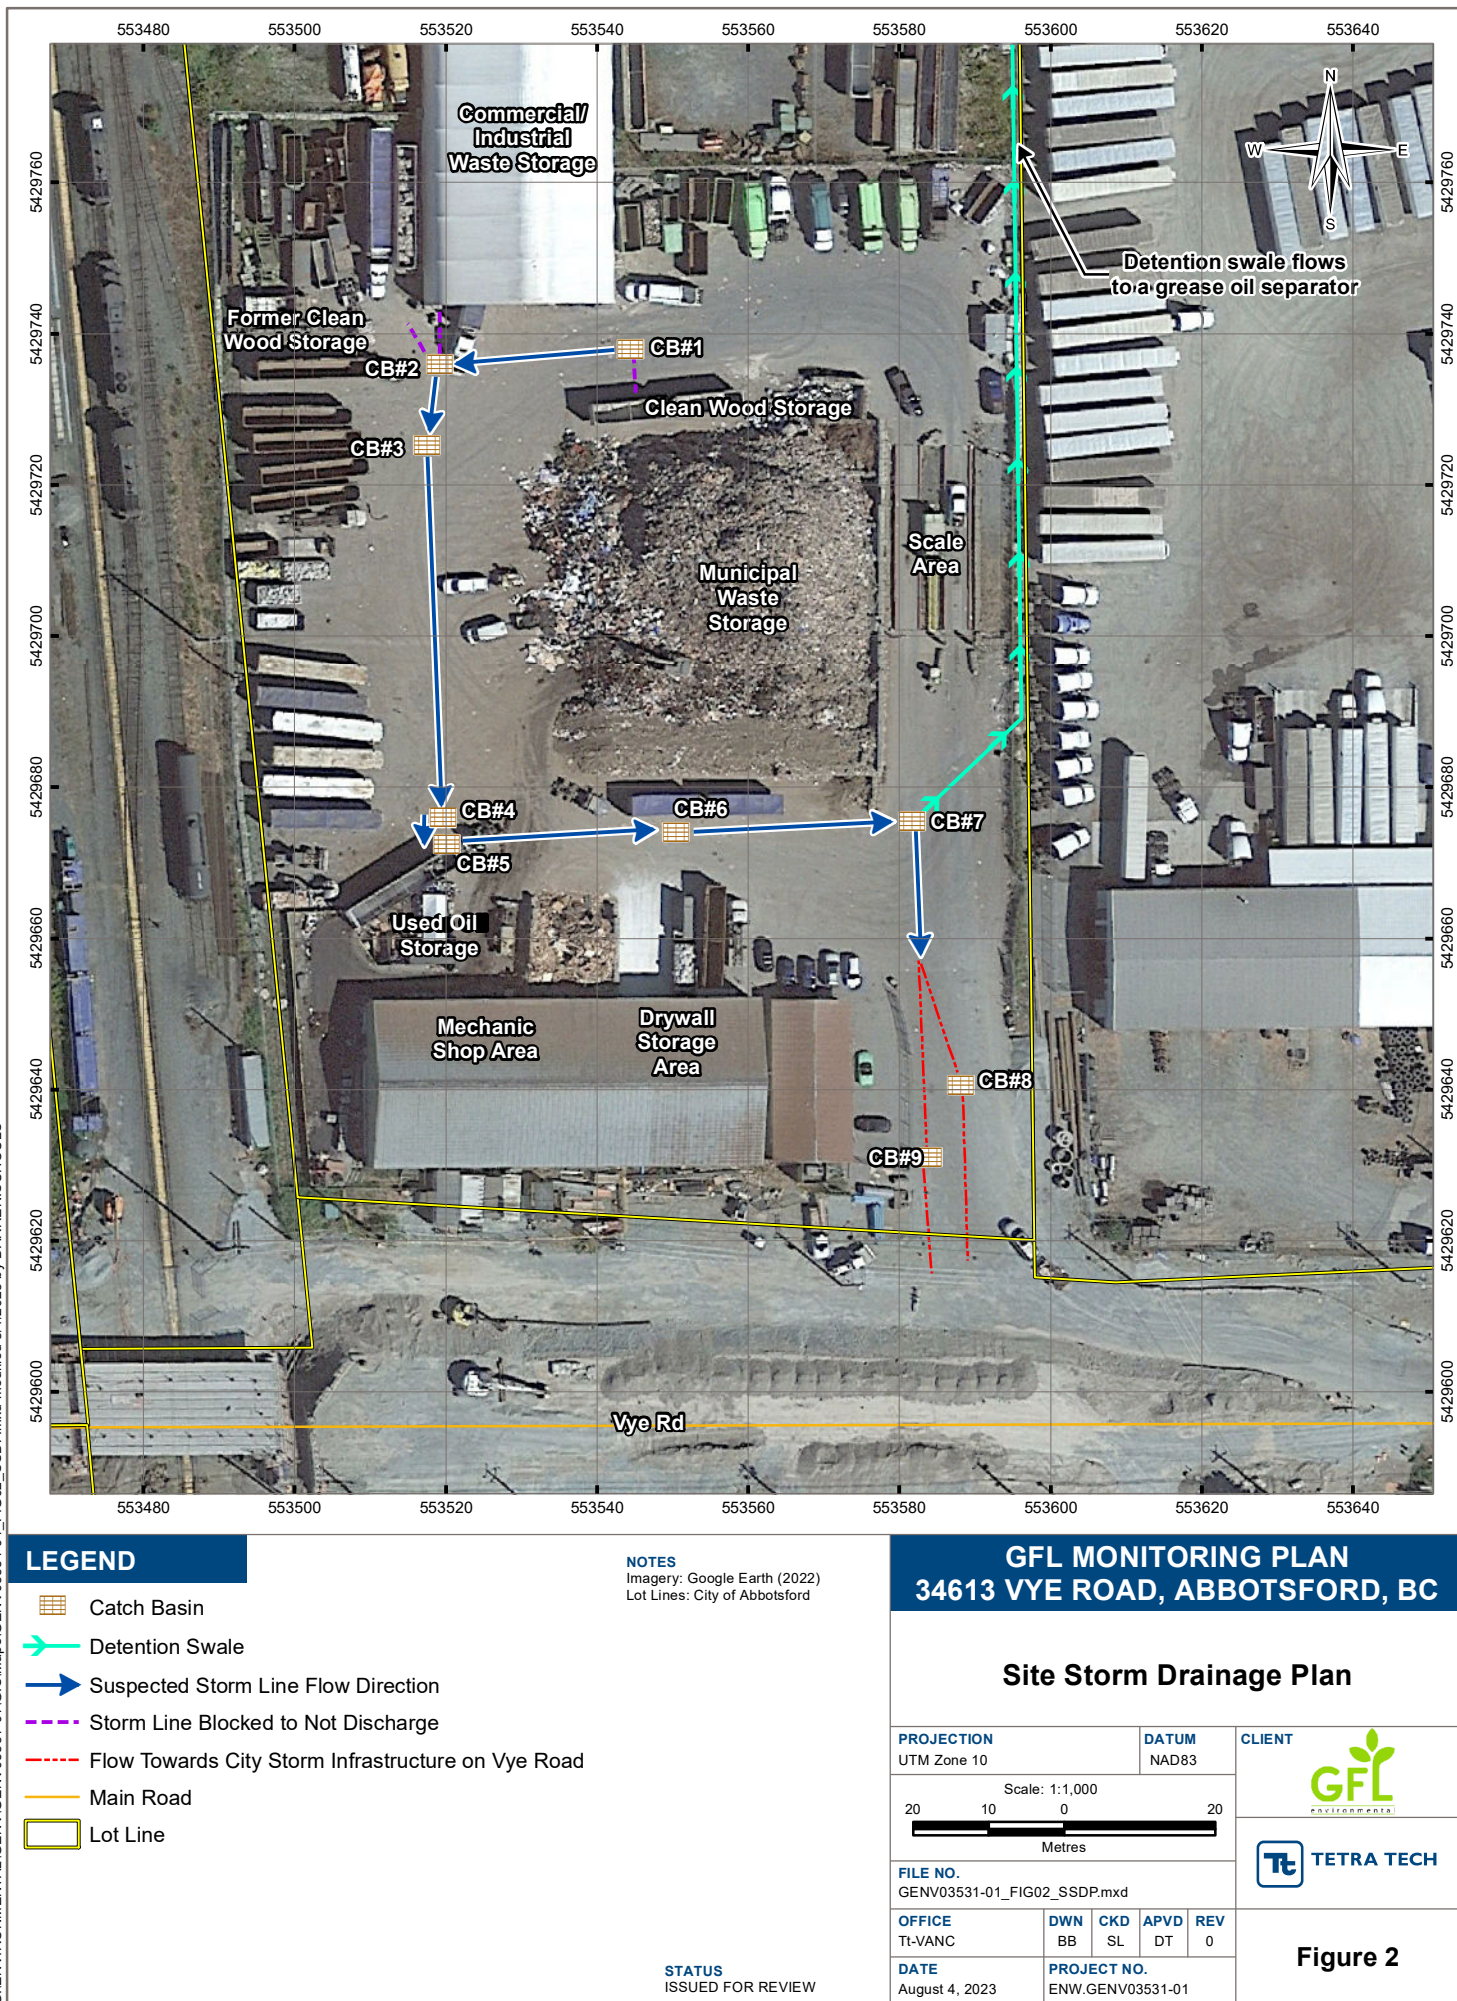
Figure 1. Site Drainage Map.

During the previous IR 182995, the Environmental and Regulatory Manager informed Officer Angus that the Facility discharges effluent into the environment from the southeast to a fish-bearing ditch network that enters Lonzo Creek. In the February 1, 2024, Analytical Results Request, Officer Angus was provided with a Site Plan and supplementary information provided by the QEP, who also determined that during high flows, effluent is discharged from the Facility to the northeast, discharging to ground through a detention swale before going through an oil-water separator (Figure 1). Officer Angus reviewed the water quality data provided by the Environmental and Regulatory Manager for the January 9 and 24th, 2024, sampling events and compared the results to both the BC Water Quality Guidelines (BCWQG) and the Canadian Council of Ministers of the Environment Guidelines (CCME) for Aquatic-Life (Freshwater) for long-term concentrations (Table 1). Officer Angus determined that the characteristics of the effluent being discharged to the environment from the southeast side of the Facility exceeded the following parameters: Nitrite, Ammonia, Chromium (VI), Chromium (III), Arsenic, Boron, Cobalt, Copper, Iron, Manganese, Toluene, Xylene, Anthracene, Benzo(a)pyrene, Fluoranthene, Naphthalene, Phenanthrene, and Pyrene.
