Report Number: 221467

**Re: Warning Letter**

On March 5, 2024, the Ministry of Environment and Climate Change Strategy (Ministry) Environmental Protection Officer Taryn Angus (Officer Angus) conducted an office review inspection of GFL Environmental Inc.'s (GFL) municipal solid waste management operation located at 34613 Vye Road, Abbotsford, BC (Facility). The inspection was conducted as a follow-up to the Inspection Report (IR) 182995 issued on March 15, 2022, resulting in a Warning and to verify compliance with the *Environmental Management Act* (EMA). Information for this inspection was provided by Jeff Styles (Environmental and Regulatory Manager, GFL).

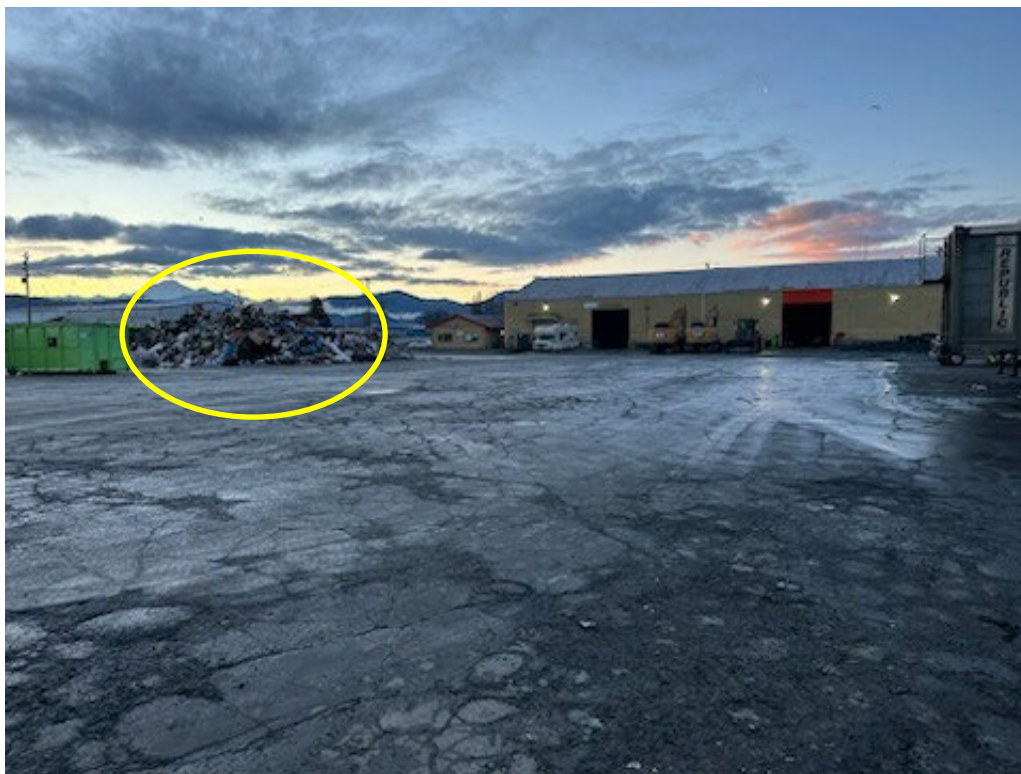
In the January 9, 2024, Information Request, the Environmental and Regulatory Manager informed Officer Angus that the uncovered waste materials consisted of construction and demolition waste. Officer Angus reviewed the photos of the Facility provided by the Environmental and Regulatory Manager and verified that the amount of waste material being stored outside and without cover has significantly reduced; however, the construction and demolition waste continue to be stored uncovered (Photos 1 and 2). In addition, Officer Angus observed significant asphalt cracking at the Facility, rendering the Facility's surface permeable (Photo 3).

Photo 1. View of the uncovered construction and demolition waste. Denoted by the yellow circle.

Cease the unauthorized discharge of waste to the environment.

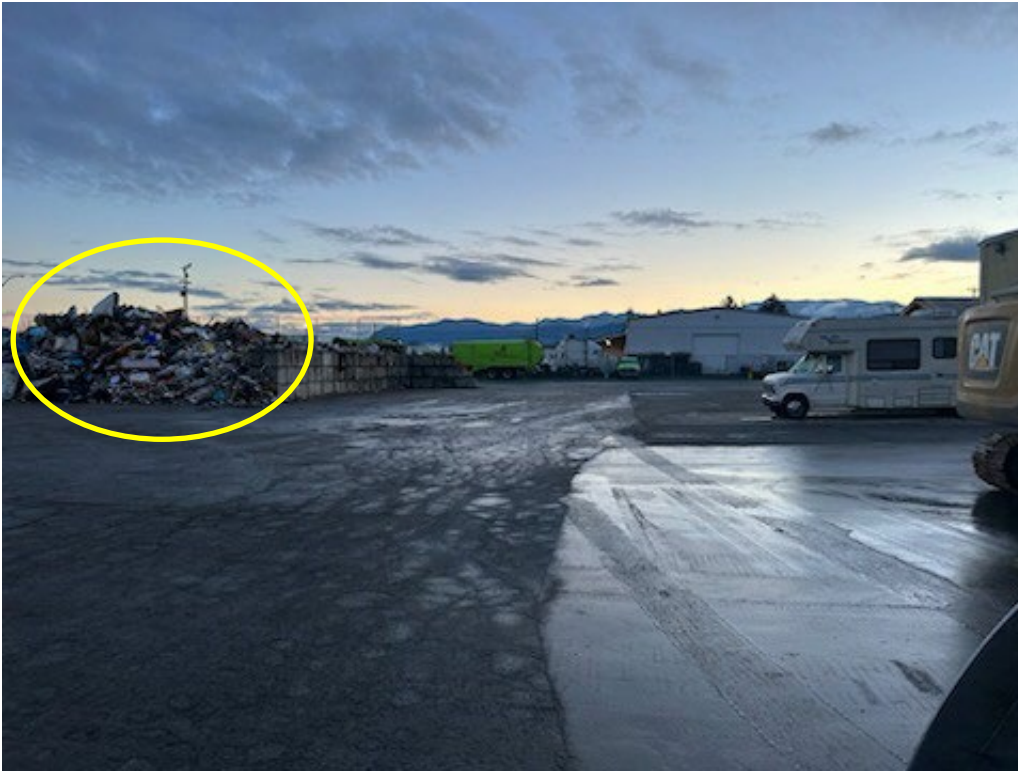
Photo 2. View of the uncovered construction and demolition waste. Denoted by the yellow circle.

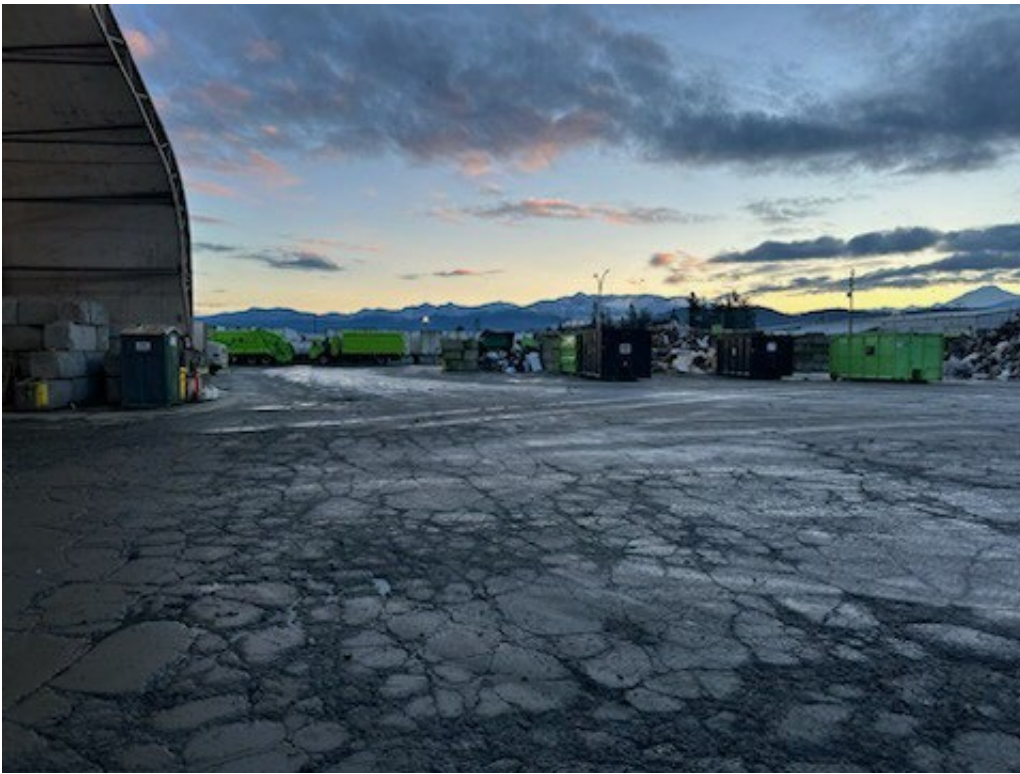
Photo 3. View of the significant asphalt cracking.
